**United States Air Force
611th Civil Engineer Squadron**

**Final
Preliminary Assessment/Site Inspection
Kalakaket Creek Radio Relay Station
Alaska**

March 1995

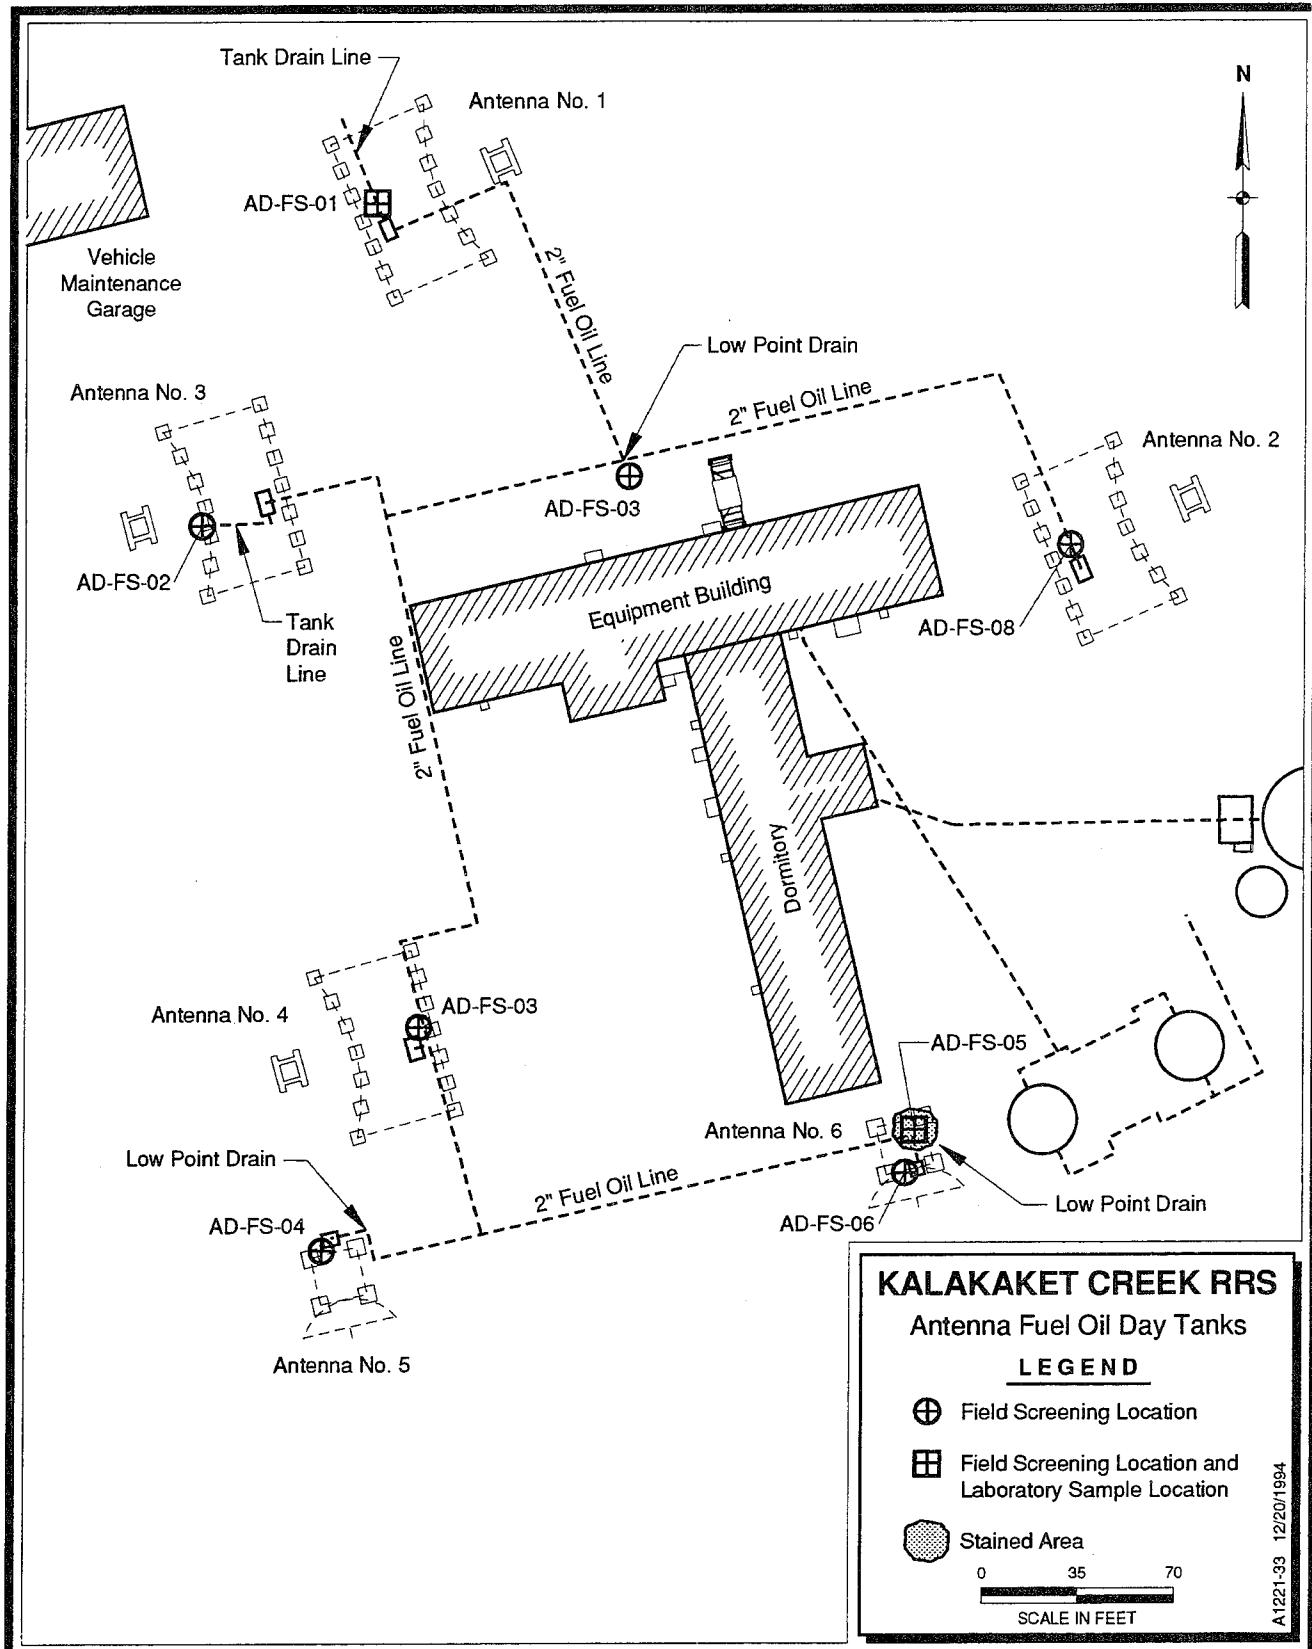
Figure 4-1. Sample Locations at the Antenna Day Tanks AOC
(Stained Area Symbol Is Not Indicative of Scale)

Table 4-4 summarizes the results of the field screening and laboratory confirmation analyses for surface soil samples collected from near the antenna day tanks. Petroleum hydrocarbons were detected in seven of the eight surface soil samples analyzed in the field using the IR screening method. The sample collected at location AD-FS-05, the low point drain beneath the easternmost microwave antenna, contained the highest concentration of TPH (21,000 mg/kg). At this sample location, a strong petroleum odor and soil staining to a depth of approximately 3 in. below the surface were observed. The staining was not visible at the surface and therefore areal extent is unknown. The sample collected at location AD-FS-01, the valve pit associated with the day tank for tropospheric antenna No. 1, contained 4050 mg/kg TPH. A moderate petroleum odor was noted at this location, but it is uncertain whether the odor originated from the soil or the nearby day tank. Concentrations of TPH ranged from 13 to 1620 mg/kg in the five remaining samples where TPH was detected, although no staining or odor was noted during collection of these samples. TPH was not detected in the sample from location AD-FS-03.

Surface soil samples were recollected for laboratory confirmation analysis at locations AD-FS-01 and -05. Samples from both locations contained DRO, but only the sample from AD-FS-

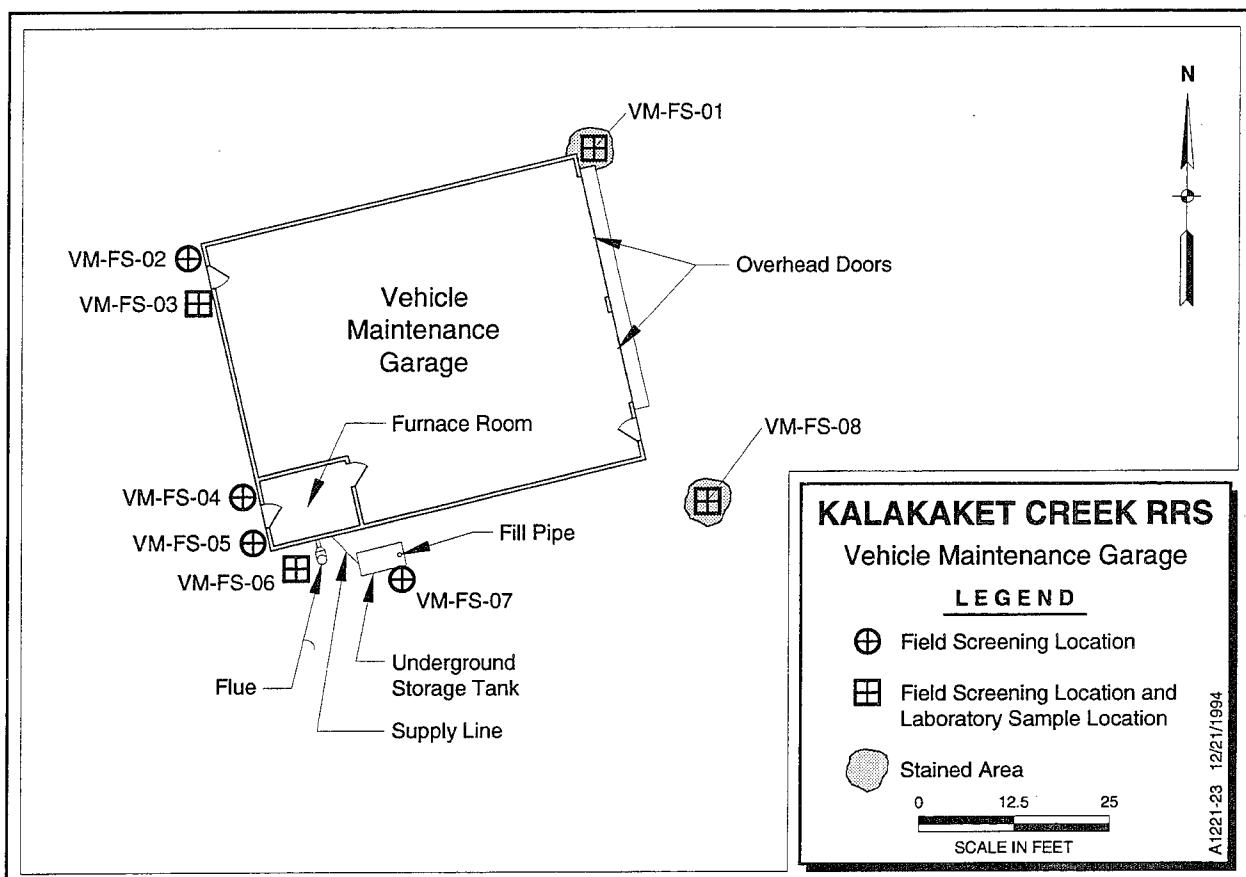
**Figure 4-3. Sample Locations at the Vehicle Maintenance Garage AOC
(Stained Area Symbol Is Not Indicative of Scale)**

Figure 4-3 illustrates the locations of field screening and laboratory confirmation samples. Surface soil samples for field screening were collected from eight locations around the building. Several of the samples were collected in areas of probable contamination, such as doorways and stained areas. The largest of these stained areas is less than 9 ft². Each of these samples were screened for TPH and AH using the field IR analyzer.

None of the confirmation samples contained GRO, VOCs, or SVOCs above screening criteria. Concentrations of DRO exceeded the State of Alaska cleanup level of 2000 mg/kg in three of the four samples submitted for laboratory confirmation, including a sample that was only found to contain 11.7 mg/kg TPH by the field screening method. The highest concentration of DRO (23,000 mg/kg) was detected in the sample collected at location VM-FS-01. Confirmation samples collected at locations VM-FS-06 and -08 contain 8700 and 7300 mg/kg DRO, respectively. The sample collected from location VM-FS-06, near the furnace flue, had an unusually grainy texture due to a high ash content, and contained low levels of polynuclear aromatic hydrocarbons (PNAs) that very likely result from the burning of fuel. The high DRO result for this sample is anomalous when compared with the field screening TPH value of 11.7 mg/kg. Qualitative observations of the chromatograms for samples from this AOC suggest that most of the DRO may be from old motor oil.

The analytical results for metals show that, with the exception of lead, no inorganic constituents in soil samples from the Vehicle Maintenance Garage exceed the UTLs. Since there are no risk-based or cleanup criteria for lead, data will be reported for all AOCs where lead exceeds the UTL.

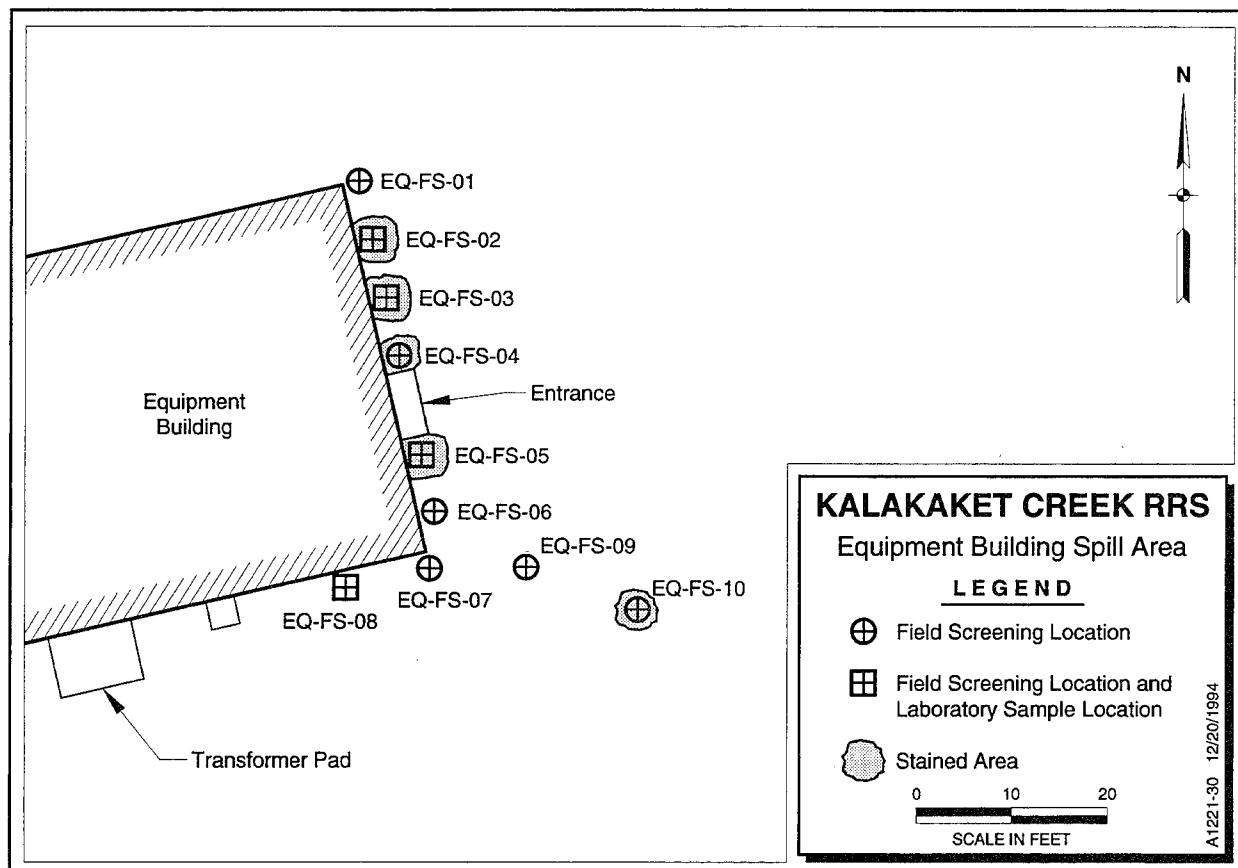
of the samples screened using the IR analyzer; concentrations range from 237 to 32,600 mg/kg. Several of the samples with elevated concentrations of TPH were collected from areas with noticeable soil staining; however, the sample collected at EQ-FS-06 had no noticeable odor or staining, yet contained the highest concentration of AH (922 mg/kg) and the fourth highest concentration of TPH (12,600 mg/kg). The only physical evidence of contamination at this location was a lack of vegetation.

Figure 4-5. Soil Staining at Sample Location
EQ-FS-10, Equipment Building AOC

A removal action should be evaluated for this AOC. Additional excavation of PCB-contaminated soil, along with confirmation sampling, should be completed to reduce the risk to human health and the environment. Following the removal action, the AOC should be recommended for NFRAP status.

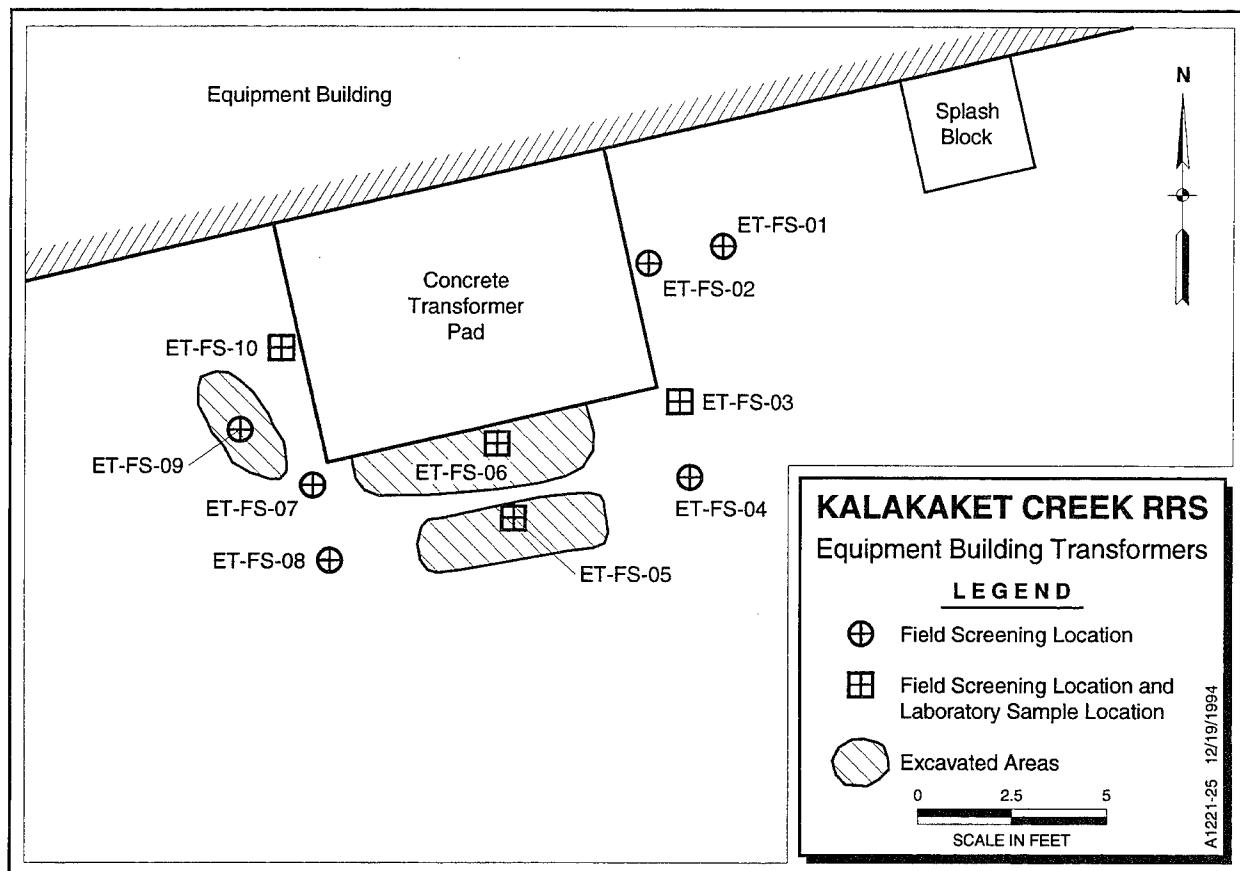
Figure 4-7. Sample Locations at the Equipment Building Transformers AOC

Surface soil samples collected from 10 locations around the transformer pad were analyzed for PCBs using an immunoassay field test kit. On the basis of the results of the field screening, four of these locations, with a range of PCB concentrations from less than 1 ppm to greater than 12.5 ppm, were resampled and submitted for laboratory confirmation analysis using EPA Method SW8080 (pesticides and PCBs). Figure 4-7 shows the sample locations for both field screening and laboratory confirmation.

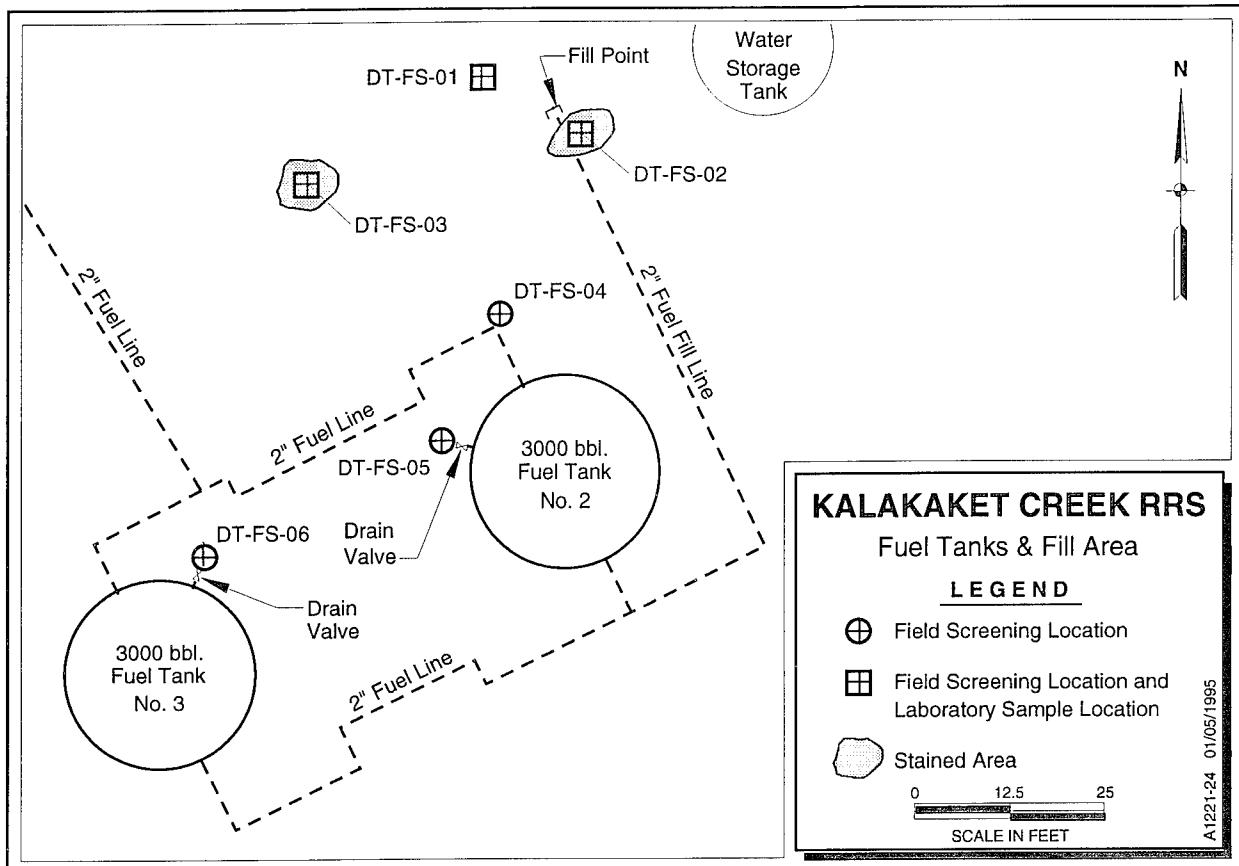
**Figure 4-9. Sample Location DT-FS-03 is the Largest Area of Soil Staining
at the Diesel Tanks and Fill Area AOC**

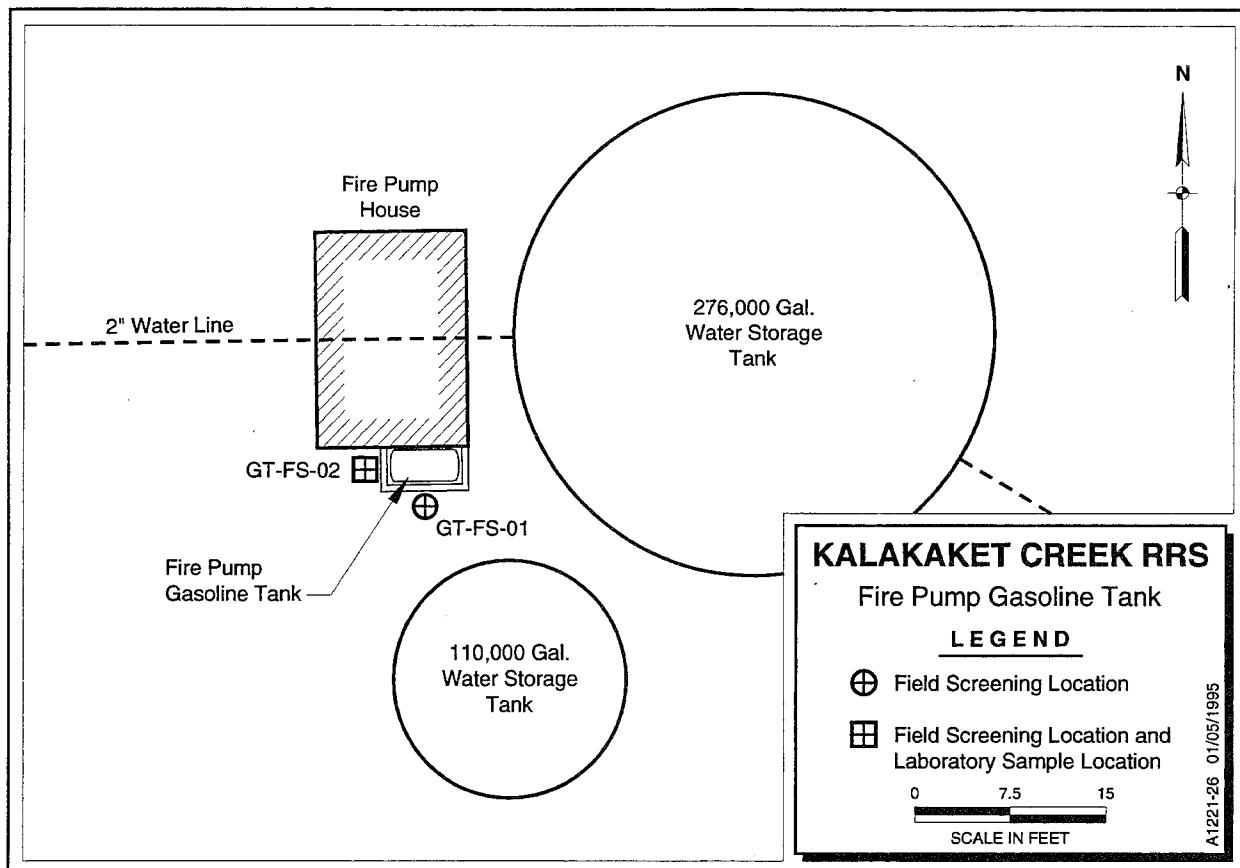
Figure 4-10. Sample Locations at the Gasoline Tank AOC

Figure 4-10 shows the location of the gasoline tank and two surface soil samples that were collected adjacent to the tank enclosure. These samples were screened for VOCs in headspace using an OVM. Although neither screening result exceeded instrument background (1 ppm), one location was resampled for laboratory confir-

The Gasoline Tank AOC is recommended for NFRAP status.

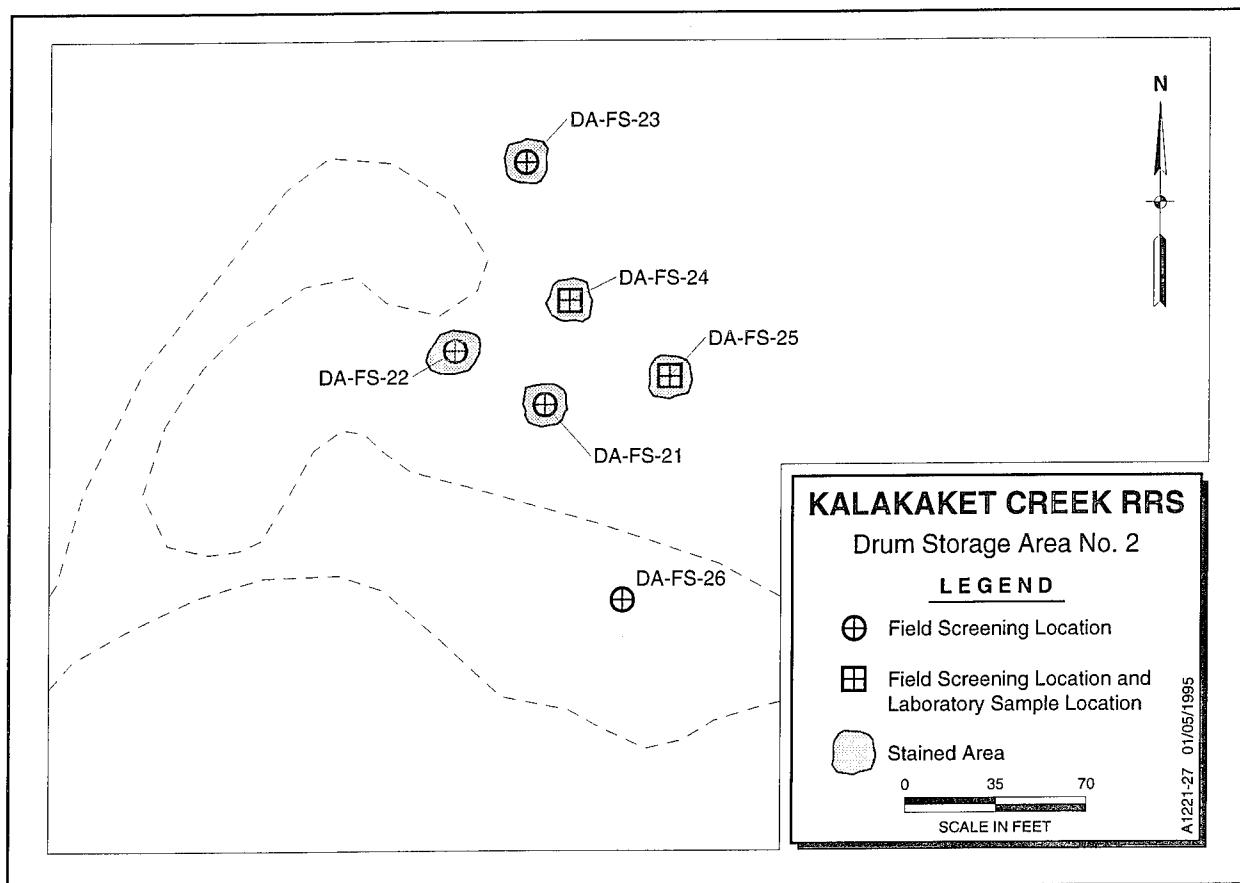
Elevated concentrations of PCBs occur in the soil at one stained area at DSA No. 2. Staining at the other sampling locations appears to be the result of contamination by DRO, possibly from motor oil or grease. The results of the field screening suggest that DDT was released at the site, either as a result of routine application or

Figure 4-13. Soil Staining at Sample Location
DA-FS-21 Drum Storage Area No. 2

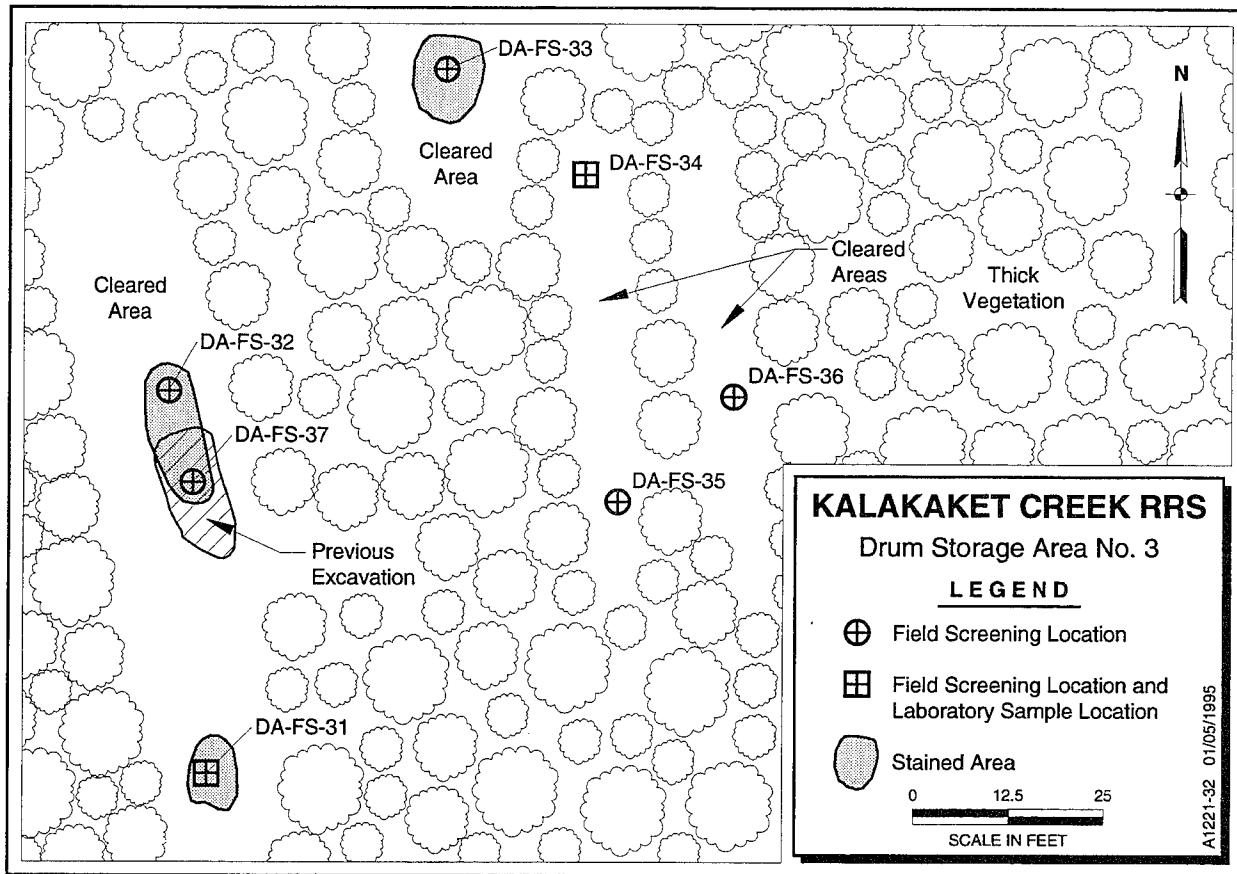
**Figure 4-14. Sample Locations at DSA No. 3
(Stained Area Symbol Is Not Indicative of Scale)**

Field screening and laboratory confirmation results are summarized in Table 4-12. TPH was detected in six of the seven screening samples, with concentrations ranging from 660 to 87,300 mg/kg. Three of the six samples were collected from areas of visible soil staining. A seventh sample, collected from a previous excavation pit (DA-FS-37), was screened only for PCBs.

PCBs were detected above 1 ppm in only one screening sample, collected at DA-FS-37 (<5 ppm). DDT was detected at levels greater than 10

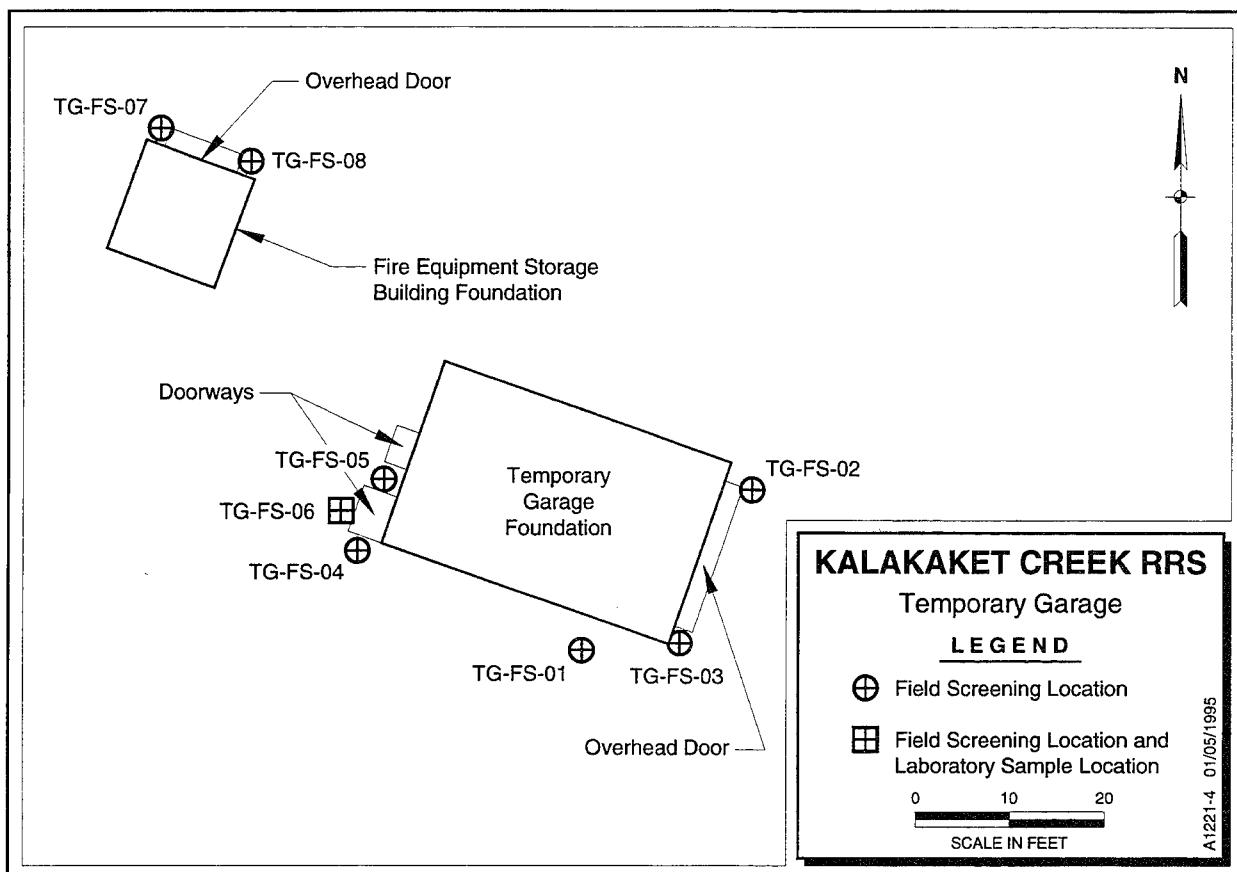
Figure 4-15. Sample Locations at the Temporary Garage AOC

Eight surface soil samples were collected from the areas around the former doors of the facility, as shown in Figure 4-15. These samples were analyzed in the field using an IR TPH analyzer. One of the locations was resampled for laboratory confirmation by methods AK101, AK102, and SW6010.

The Temporary Garage AOC is recommended for NFRAP status.

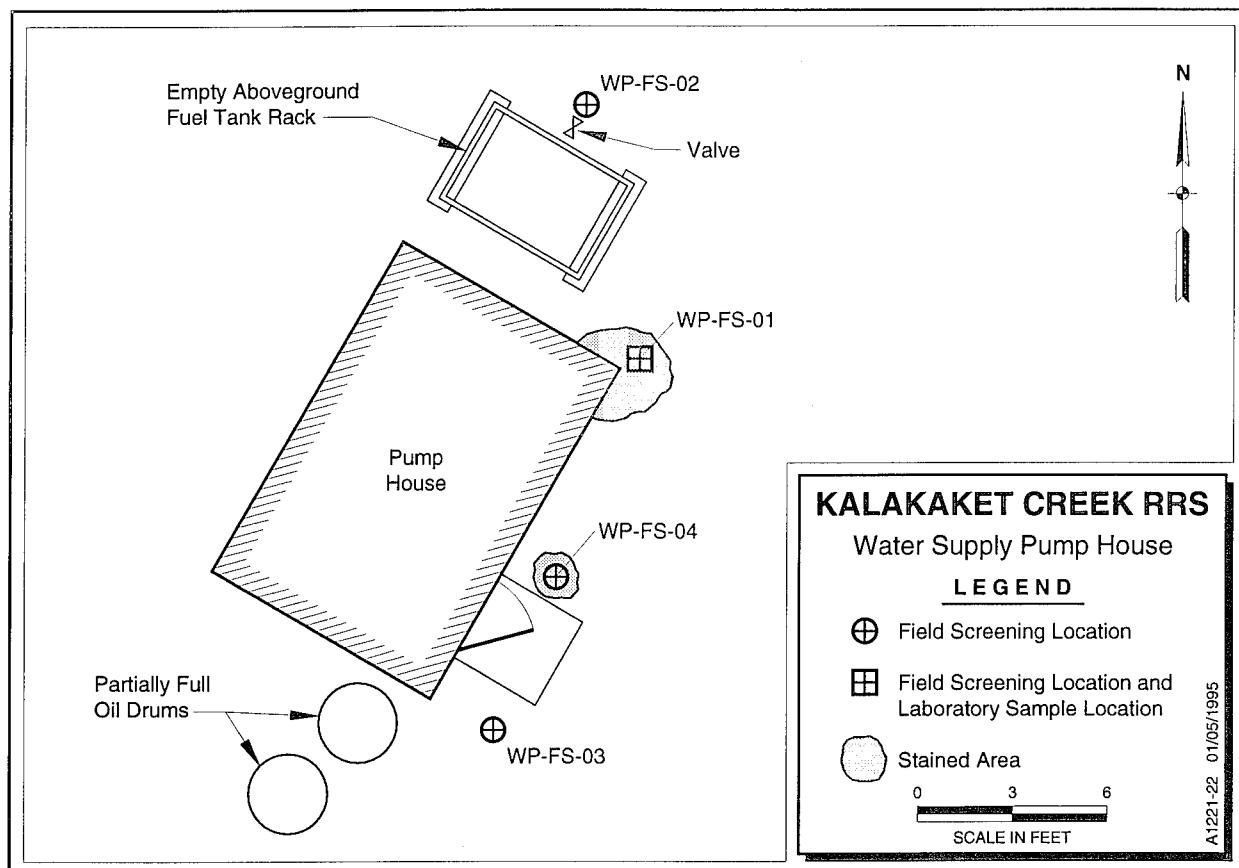
Figure 4-17. An Area of Soil Staining at the Water Pump House AOC (WP-FS-01)

Because of the proximity of this AOC to a waterway, the stained soils should be excavated and removed, followed by confirmation sampling. The partially full drums of oil should also be removed.
